Knowledge and Experience in the Strengthening of Structures

Introduction to Strengthening using Externally Bonded Reinforcement

Structural Strengthening /March 2004

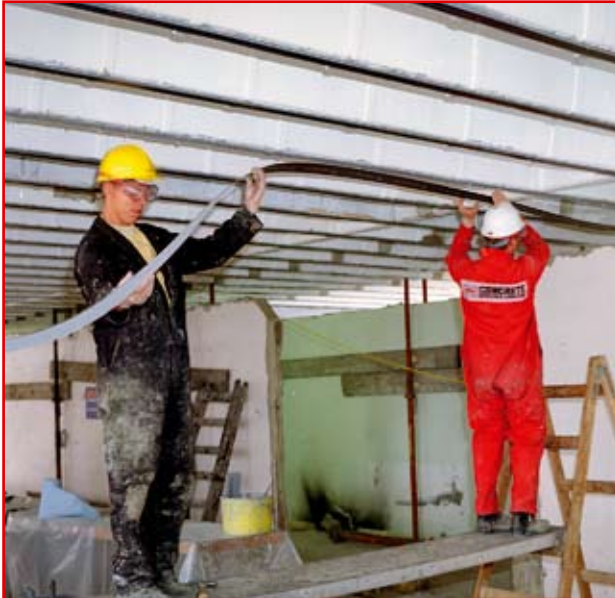
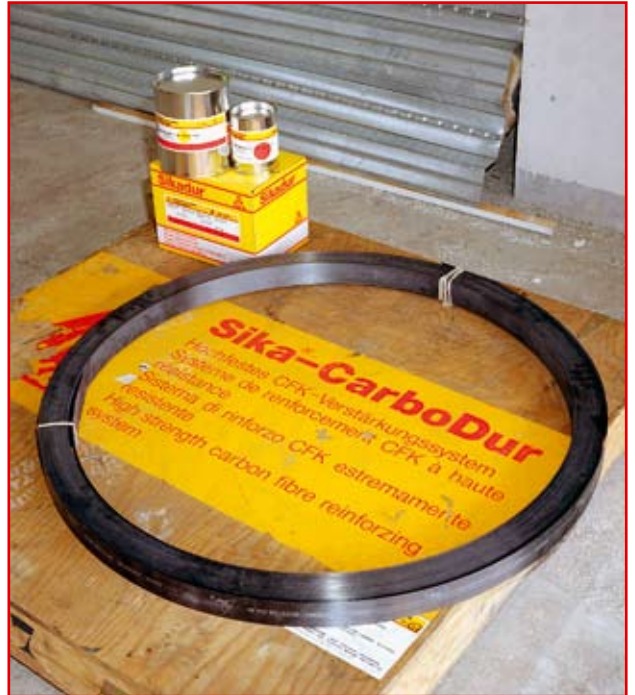
The limited space available in major towns and cities can often lead to additional floors being added to existing buildings. Sometimes the original roof may not be able to carry the new floor loads and extra strengthening is required.

During the extension project at Kings College Hospital in London, this problem was solved by installing 1.3 kilometres of the **Sika CarboDur[®]** system to the soffit of the original roof.

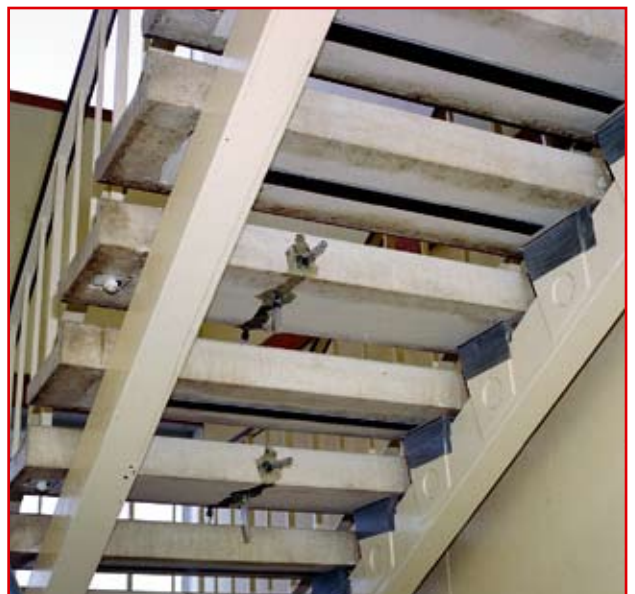
A simple mistake during construction can lead to big problems. When this school staircase was installed with the stair treads upside down, cracks quickly appeared on the underside of the treads. To minimise the disruption to the school caused by the potential replacement of the staircase, short lengths of the **Sika CarboDur[®]** system were bonded to the underneath of each tread.

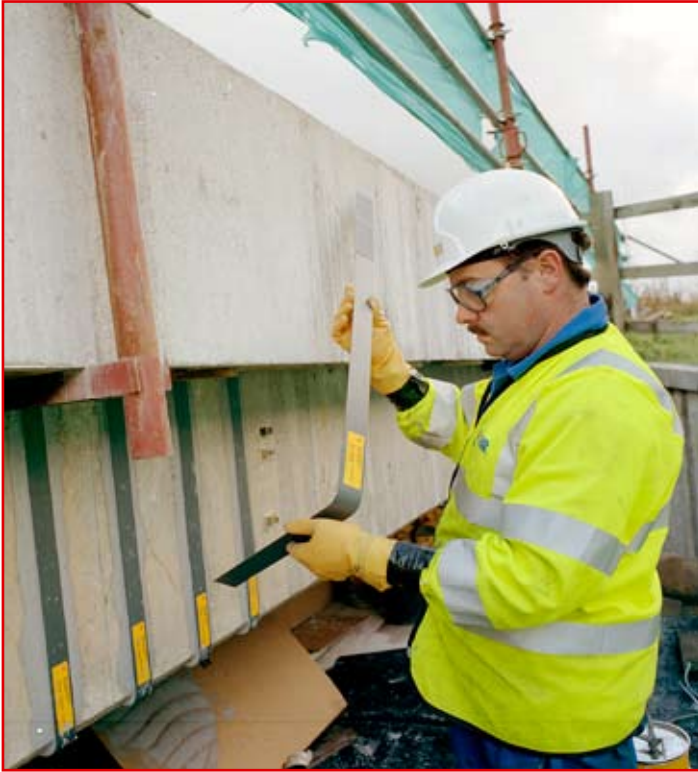
Shear strengthening of existing structures has traditionally proved difficult. The development of the **Sika Carbodur® L Plates** provides a solution to the problem on uniform cross sections. The **Sikawrap® Composite Fabric** system provides an alternative on other cross sections.

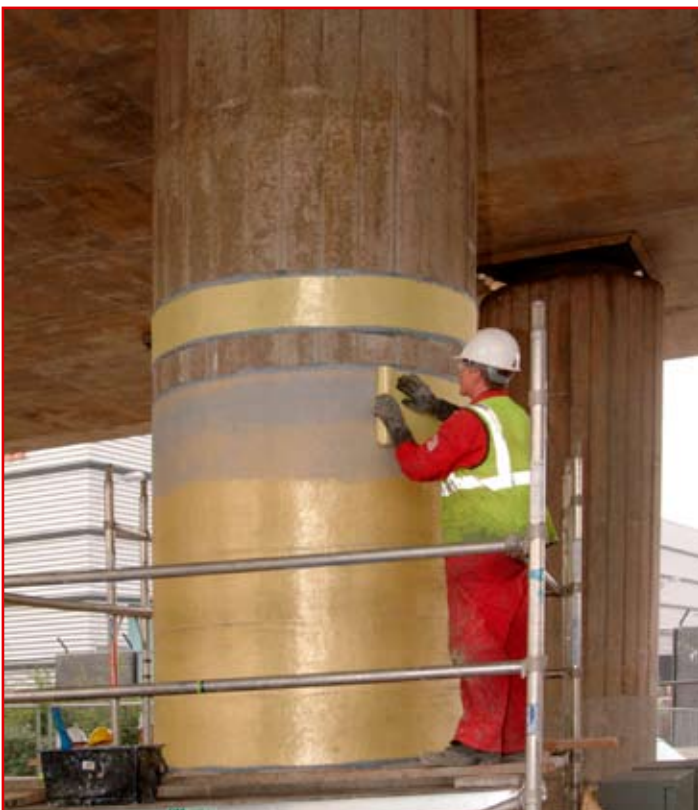
Impact resistance for columns can also be improved by the installation of the **Sikawrap®** system, which includes carbon, aramid and glass fabrics.

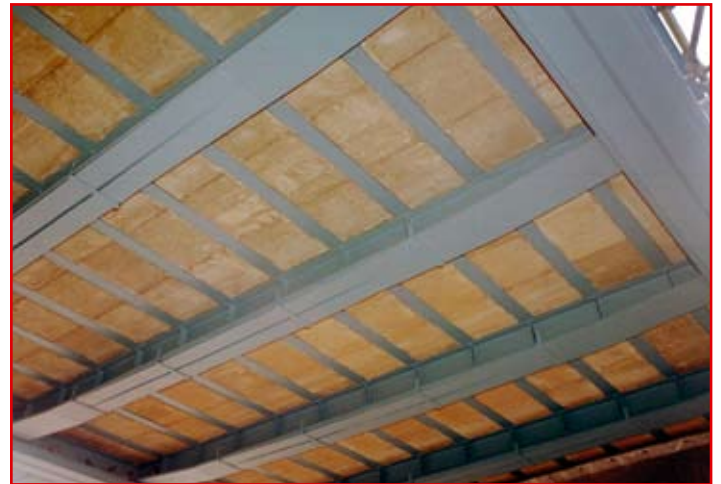
Metallic Beams

Detailed long-term research carried out in association with Devonport Management Ltd and London Underground Ltd has led to the development of the **Sika Carbodur® DML** system for strengthening metallic structures such as cast iron or steel. The application is suited to civil bridge structures, historic buildings and steel structures.

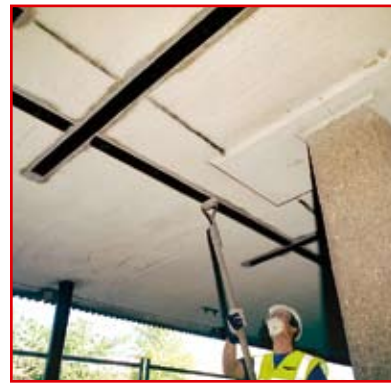
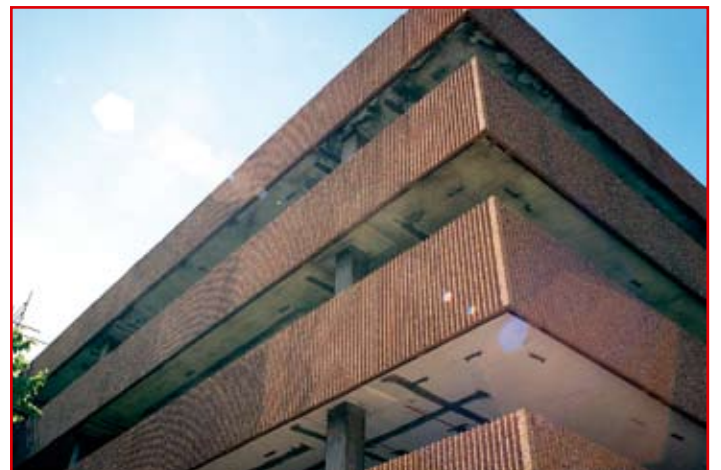
Project Carlton Street Car Park

The refurbishment of this Scunthorpe Car Park included the requirement to increase the load carrying capacity of the top deck. This was achieved by bonding 6,400 metres of **Sika Carbodur®** plate to the soffit under the deck.

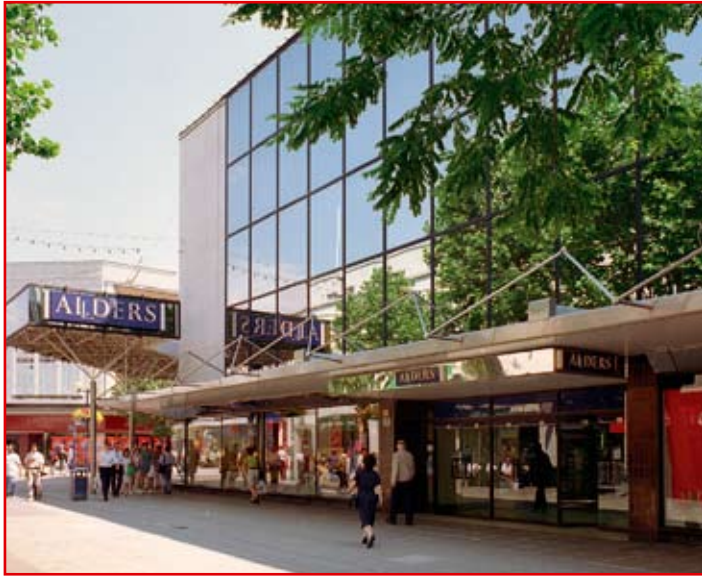
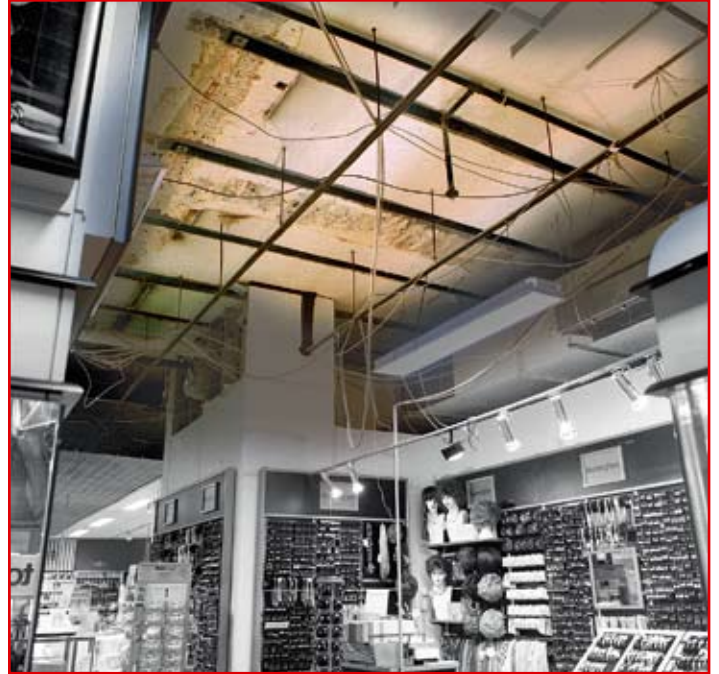
Cutting Holes In Slabs

The use of the **Sika Carbodur® System** can eliminate the requirement for service diversions, reduce the visual impact of the strengthening and minimise disruption to the use of the building.

Improved access requirements for commercial and retail structures often involve the installation of new lifts and escalators. The holes in the floor slabs to accommodate these improvements can create a difficult structural problem. The nature of these structures means that live services are close by and may need to be expensively diverted if traditional steelwork methods are employed.
